# **Bench Test Station Challenge**

California State University Dominguez Hills

QAS 515.41

Bench Test Station Challenge

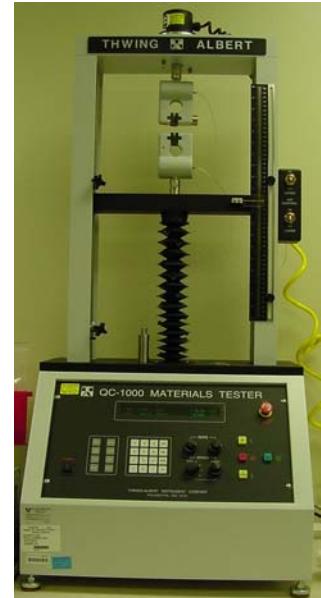
One of the many bench test performed at Guidant (GDT) is destructive tensile testing of materials in the Receiving Inspection (R.I.) area. The tester is a large piece of equipment. The chassis design is such that the clamping jaws are located high up between tall rails, and the controls and data view screen are located on the base. Operators complain that the procedure requires too much reaching to load and unload test samples. Some operators actually use a small step stool to do this. The controls and display are below eye level. The operators sometimes sit down to record the data.

The equipment is located in a well-lit and climate-controlled environment. It is placed on a standard bench-top work surface. This station is laid out for a standing operator. The test samples are cut from longer items such as polymer tubing or spools of wire and are prepared on an adjacent bench. The large working area prohibits sitting. However, a chair is located at the station because some operators naturally try to sit down when recording data. The chair is an obstacle when it is not in use, which is most of the test cycle.

There are two primary operators of this equipment, one on each shift. Therefore, the problem was assessed based on their needs. Additional operators fill in on occasion, however the anthropometric data for those operators are within the ranges presented below. The bench top is 36" above the floor.

Applicable Anthropometric Data	Operator "A"	Operator "B"	Related Equipment Design Elements	Height from Floor
Gender	Male	Female	-	-
Stature (Ht.)	69"	65"	Frame Height	84"
Elbow Height – Standing	43"	40.25"	Run Controls with Data Display	48"
Arm Length	30.5"	29"		
Overhead Reach	85.5"	82"	Top Grip	76"
			Grip Controls – Open/Close	68"

- The equipment controls are well above elbow height.
- The data display is in the same location as the controls and well below eye level, obvious from the distance (17"-21") below the stature measurement.
- The height of the top grip (76") is greater than either stature measurement. All samples must first be loaded into the top grip for testing. Loading and unloading of all samples is accomplished by overhead reaching. This is the main reason for the operator complaints and why they employ the stepstool.

(Note: The top grip is stationary on this equipment. The bottom grip moves downward during the test.)
